[Docket No. FAA-2013-0695; Directorate Identifier 2011-NM-264-AD; Amendment 39-17726; AD 2014-01-03]

Airworthiness Directives; Saab AB, Saab Aerosystems Airplanes

2014-01-03 **Saab AB, Saab Aerosystems**: Amendment 39-17726; Docket No. FAA-2013-0695; Directorate Identifier 2011-NM-264-AD.

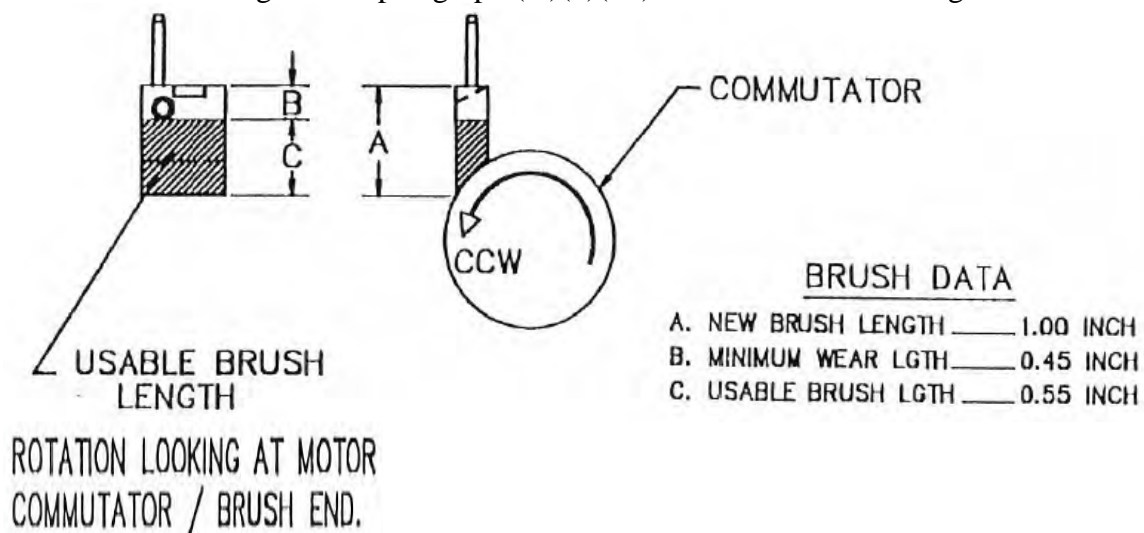
Figure 1 to paragraph (m)(4)(vii) of this AD – Measuring the Brush

- (4) The amount of wear on the brushes (including overall length and total calculated wear), calculated as specified in paragraphs (m)(4)(i) through (m)(4)(ix) of this AD.

- (vi) Lift brush spring and remove brush with wire hook or scribe.
 - (vii) Measure each brush as shown in figure below and record values.

(viii) Using the brush with the shortest measured length, calculate the wear by subtracting the measured value from 1.000 inch.

- (11) Install each new brush set by lifting brush springs, sliding brush into holder (with brush leading edge in direction of motor rotation) and lightly releasing the brush spring on the brush. (See Figure 1 to paragraph (m)(4)(vii) of this AD.) CAUTION: Do not allow brush spring to strike hard into place or damage to brush may result.

(ix) Replace brushes in accordance with the instructions specified in paragraphs (j)(9) through (j)(23) of this AD.
